Beaver Dam Lake Aquatic Plant Management Plan

Prepared for
Beaver Dam Lake Management District

February 2021

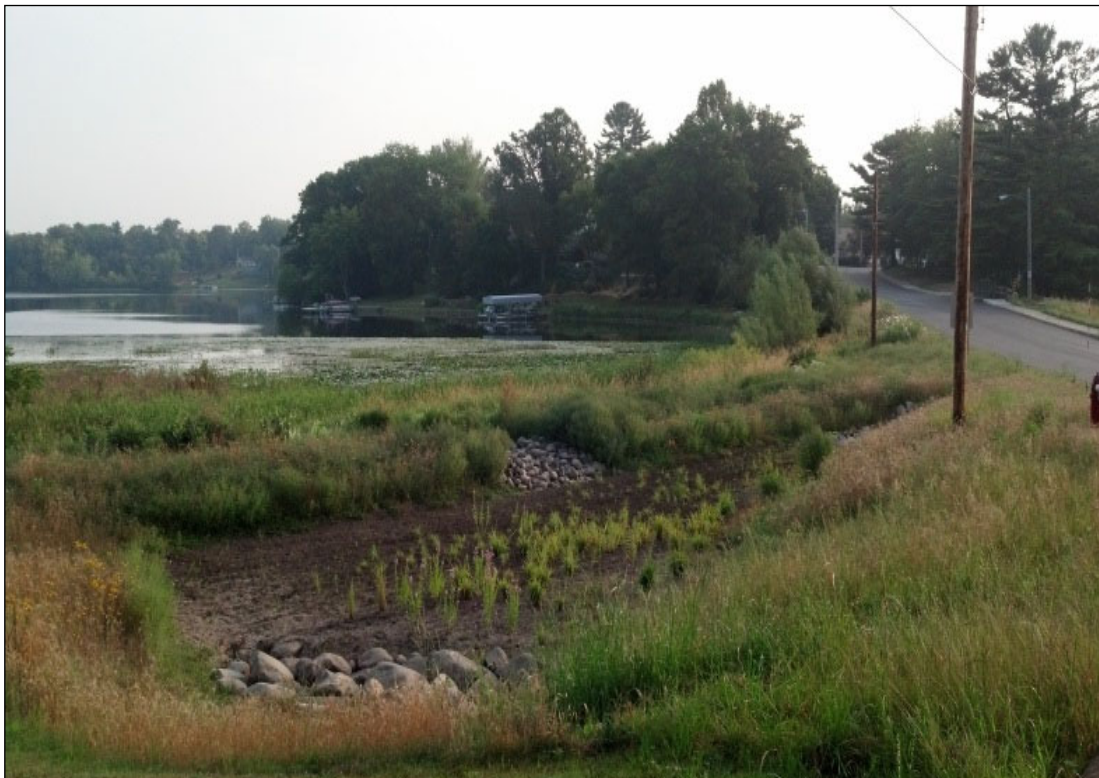
Stormwater runoff is treated by stormwater treatment ponds, including the stormwater treatment pond pictured above, before entering Library Lake. Photo Credit: EOR, Inc.

The BDLMD has constructed three stormwater treatment ponds to treat stormwater runoff to Library Lake and intends to construct a fourth stormwater treatment pond in 2021. Information about the stormwater management project is found in a YouTube presentation found at the link below:

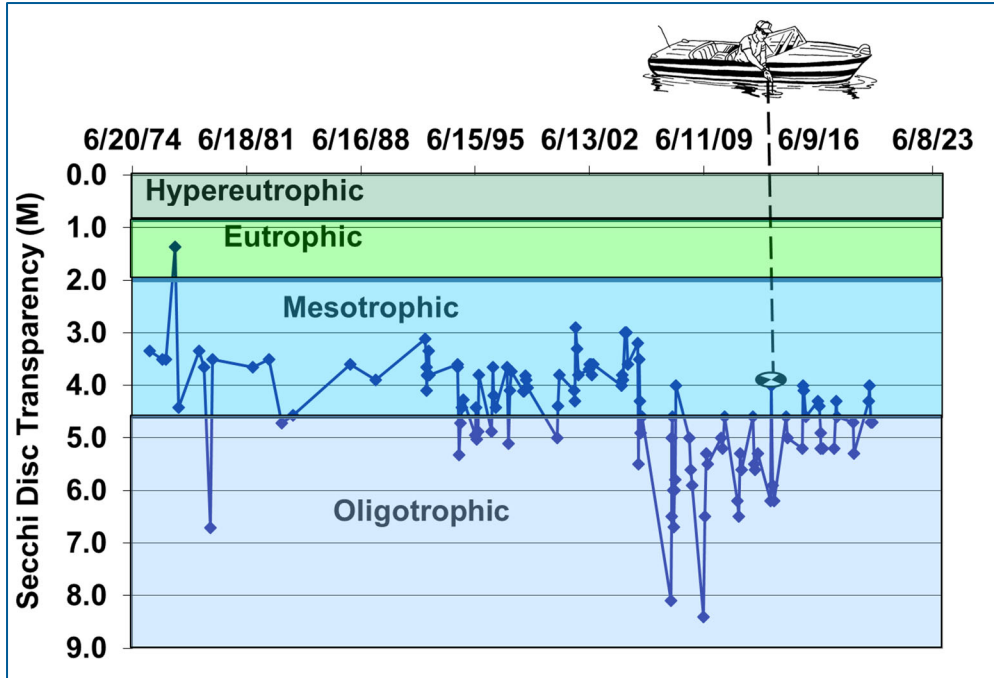
Figure 5-1 1975-2019 Beaver Dam Lake Secchi Disc Transparencies: West Lake (West End)

A summary of historical Secchi disc data is presented on Figure 5-1 through Figure 5-7. A detailed discussion of Beaver Dam Lake water quality is found in *2007 Beaver Dam Lake Water Quality Study* (Barr, 2008a).

Water quality of Beaver Dam Lake has varied, depending upon location. Water quality in West Lake, Williams Bay, and Rabbit Island Bay (locations shown on Figure 1-2) has generally been excellent to good, ranging from oligotrophic (low nutrients, crystal clear) to mesotrophic (moderate nutrients, good water quality) (Figure 5-1 through Figure 5-4). Water quality in Library Lake (location shown on Figure 1-2) has been good to poor, ranging from mesotrophic (moderate nutrients, good water quality) to eutrophic (high nutrients, poor water quality) (Figure 5-5). Water quality in East Lake (location shown on Figure 1-2) has been excellent to very poor, ranging from oligotrophic (low nutrients, crystal clear) to hypereutrophic (extremely high nutrients, extremely poor water quality) (Figure 5-6). Cemetery Bay (location shown on Figure 1-2) water quality has been good to very poor, ranging from mesotrophic (moderate nutrients, good water quality) to hypereutrophic (extremely high nutrients, extremely poor water quality) (Figure 5-7).

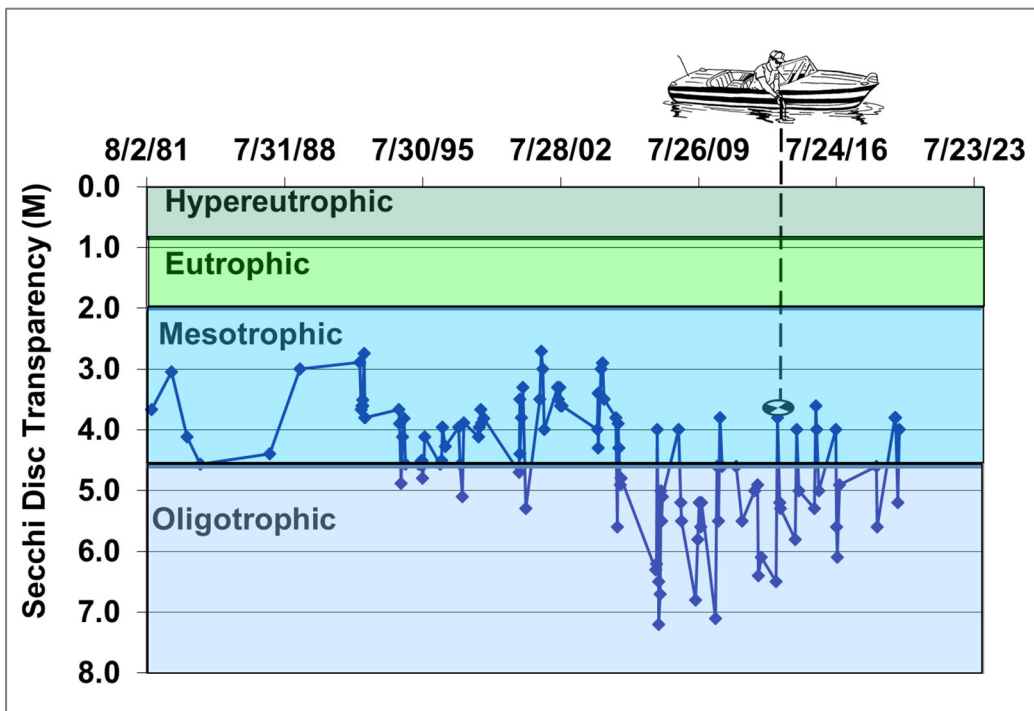
Figure 5-2 1981-2019 Beaver Dam Lake Secchi Disc Transparencies: West Lake (NE of Eagle Point)

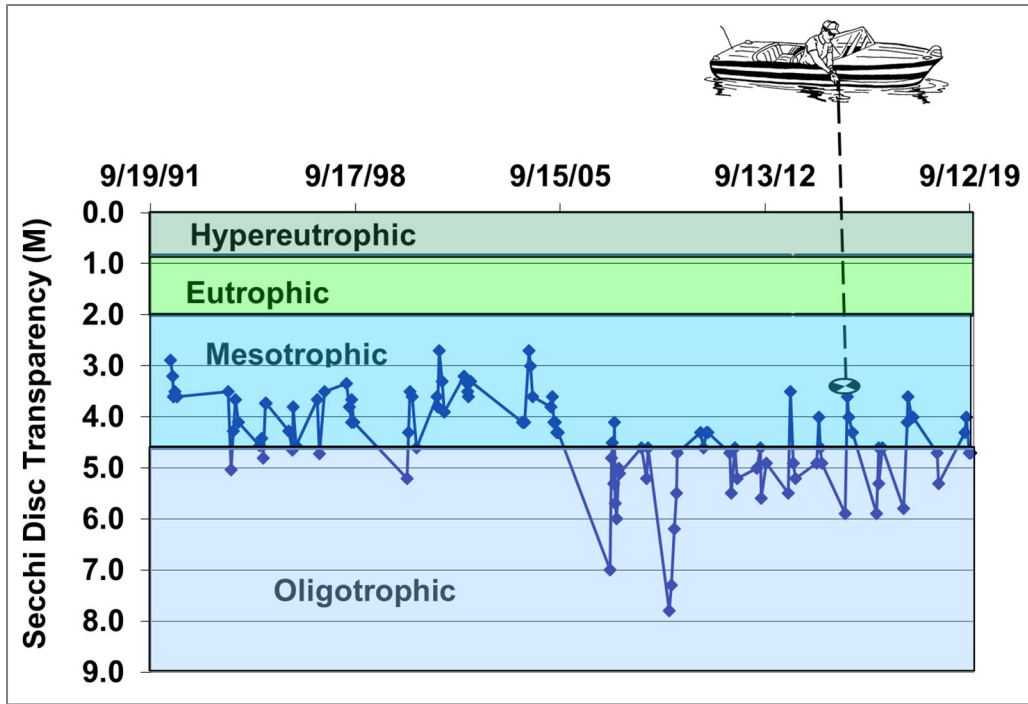
Figure 5-3 1992-2019 Beaver Dam Lake Secchi Disc Transparencies: Williams Bay

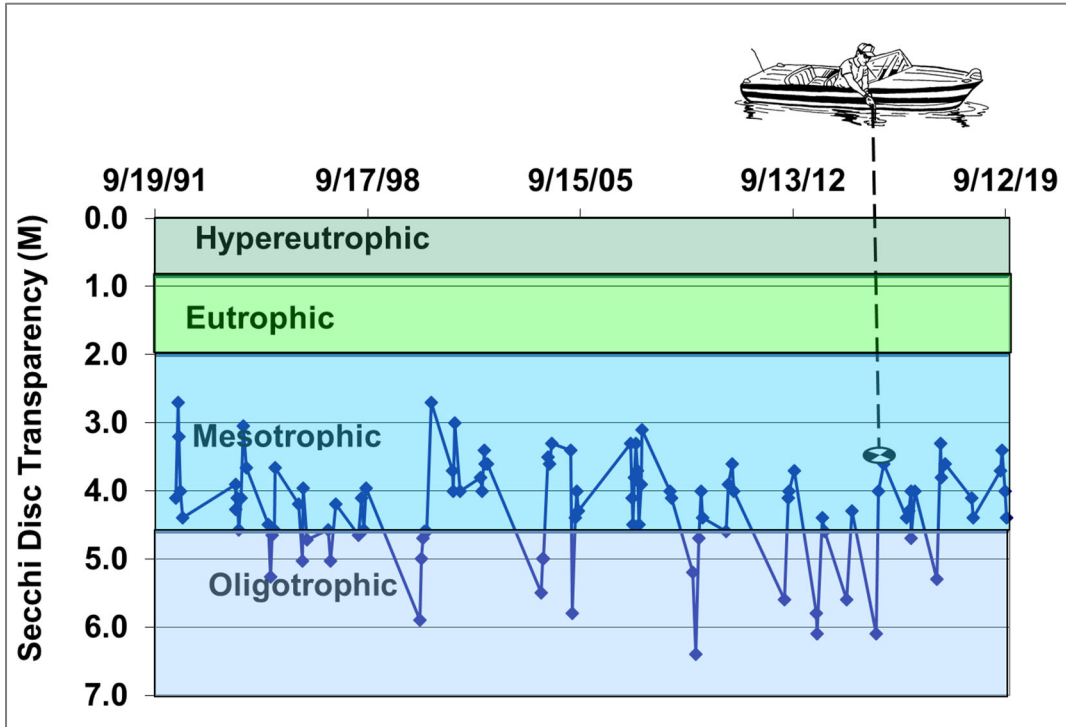
Figure 5-4 1992-2019 Beaver Dam Lake Secchi Disc Transparencies: Rabbit Island Bay

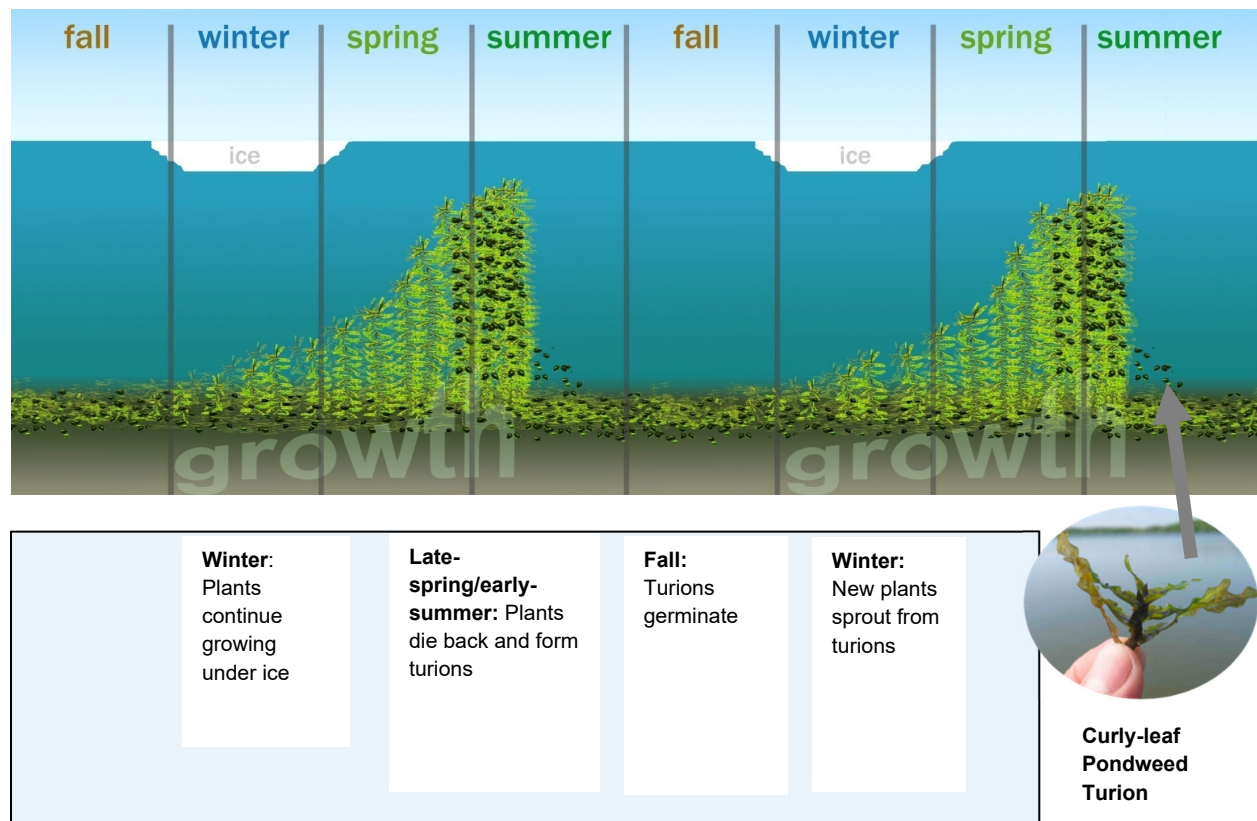
Figure 7-2 Curly-leaf Pondweed Growth Cycle

CLP differs from native plants that generally begin their growth cycle in spring and end their growing season by fall. CLP begins its growing cycle in late summer, continues to grow through the fall and winter, grows very rapidly in spring after ice-out, and finishes its growing cycle in early summer (Figure 7-2). CLP generally reproduces from turions, overwintering buds, which perform a similar role as seeds in native species. Studies show that each CLP plant can produce up to 900 turions (Catling et al., 1985) and turions can remain viable for several years (Newman 2009). CLP's ability to produce large numbers of turions and its unique growing cycle give this species a competitive advantage over native species. CLP begins its growth cycle when native species have ended their growth cycle and are no longer competing for space on the lake bottom. CLP is actively growing when natives begin their growth cycle. Hence, natives are restricted to areas not occupied by CLP.

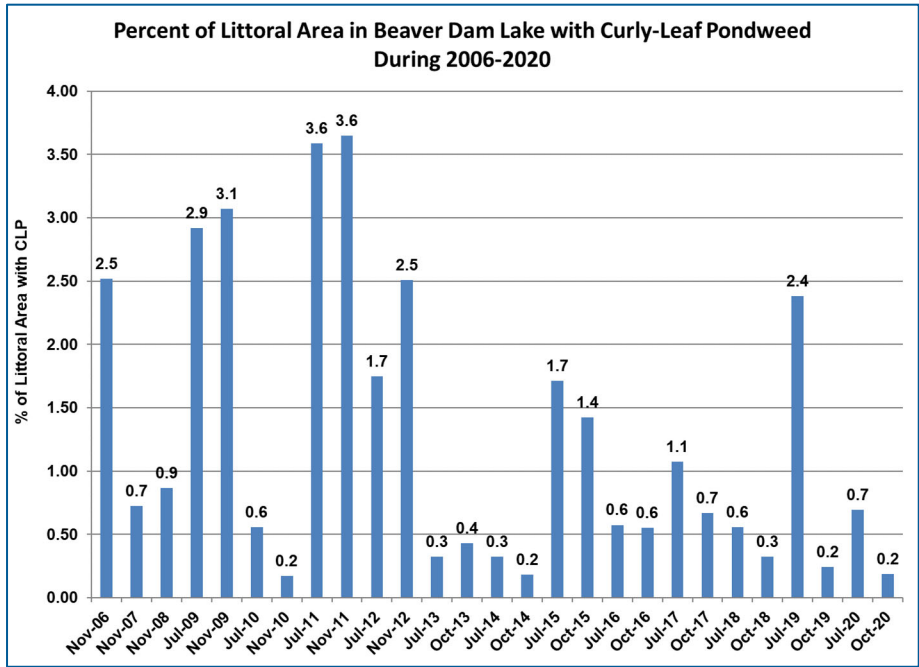
Figure 7-4 Percent of Littoral Area of Beaver Dam Lake with Curly-leaf Pondweed during 2006-2020

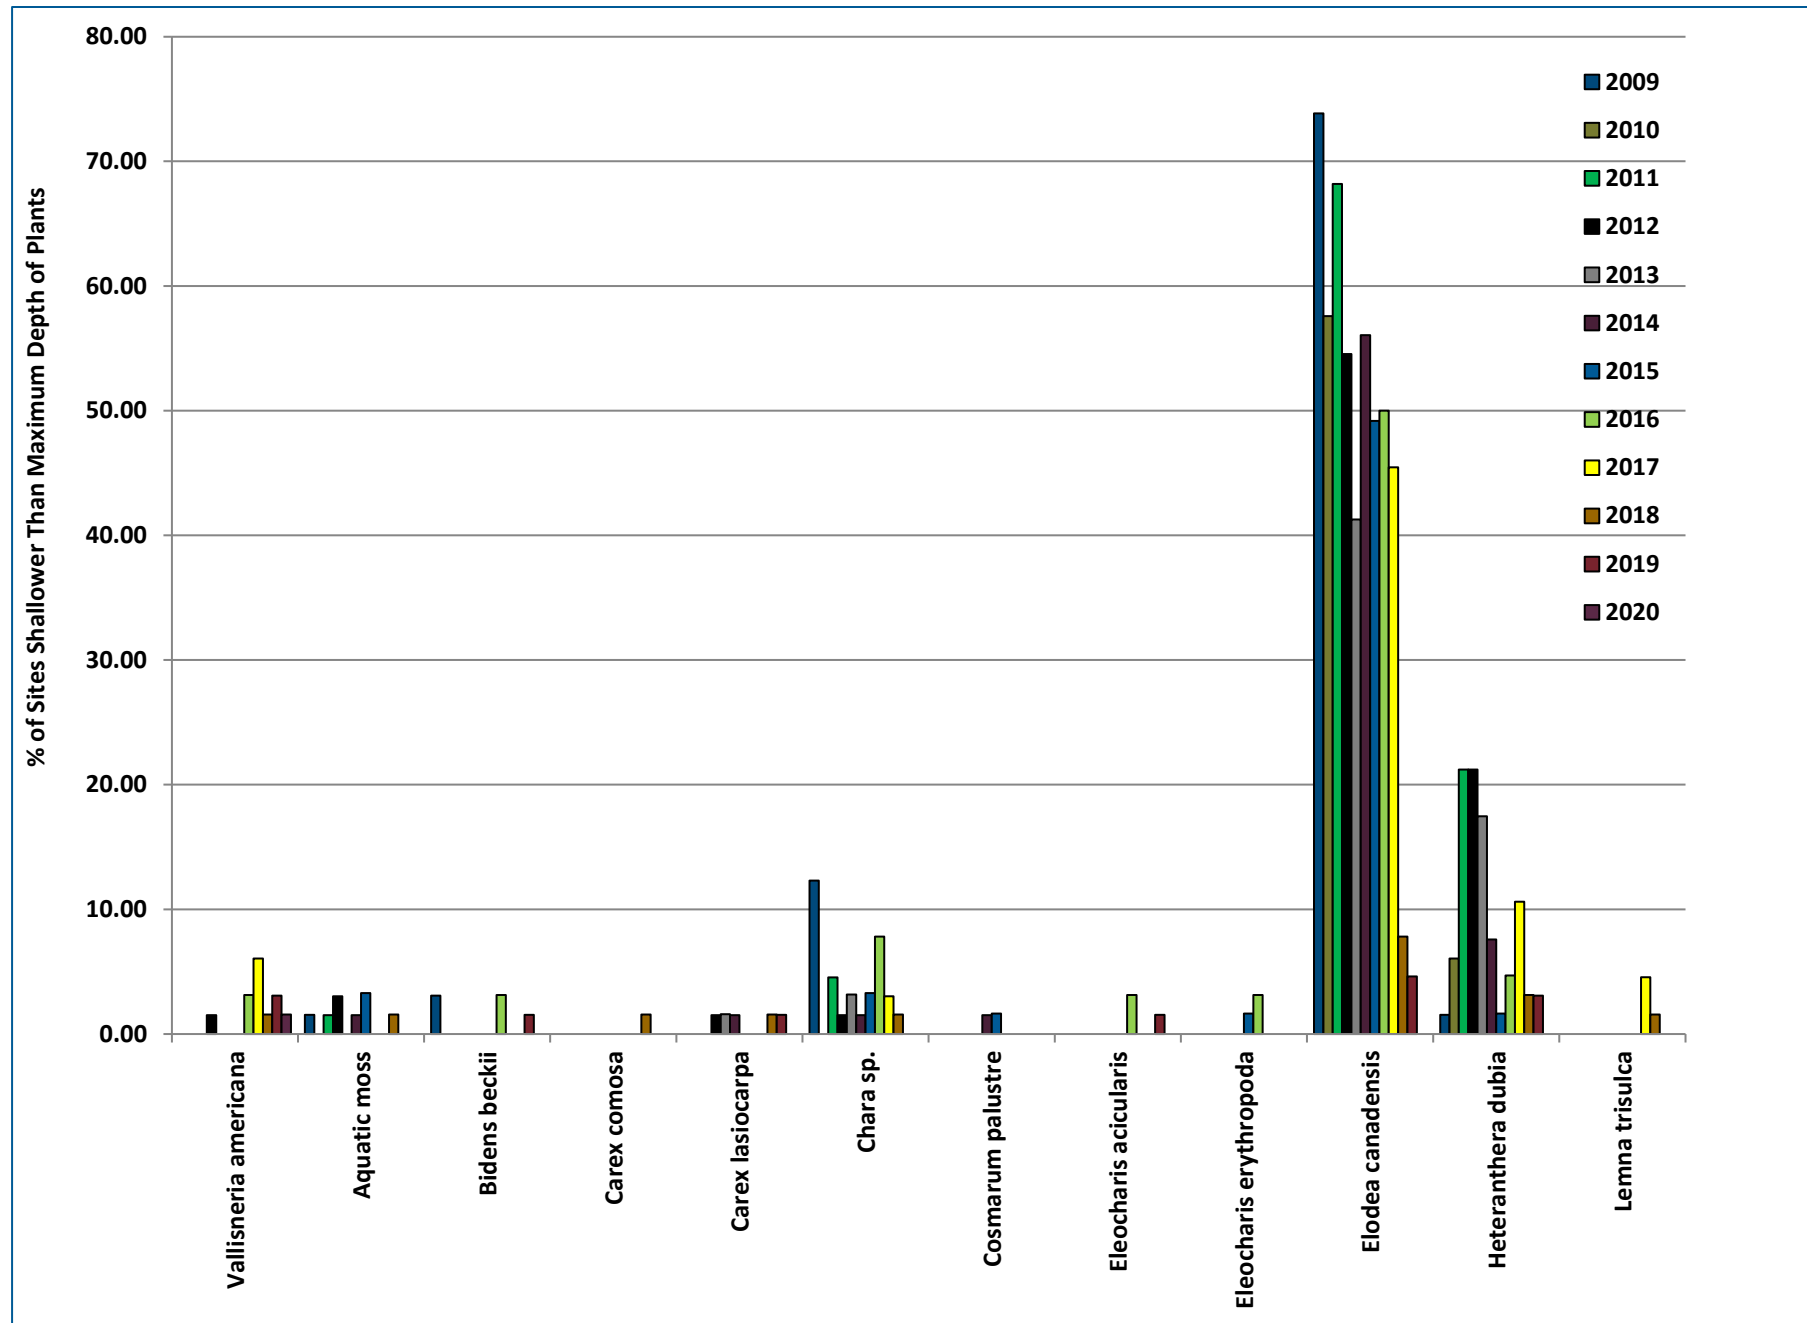
Figure 8-28 2009-2020 Norwegian Bay Frequency of Occurrence (% of Sites Shallower Than Maximum Depth of Plants)
